Existing Condition

Option 0

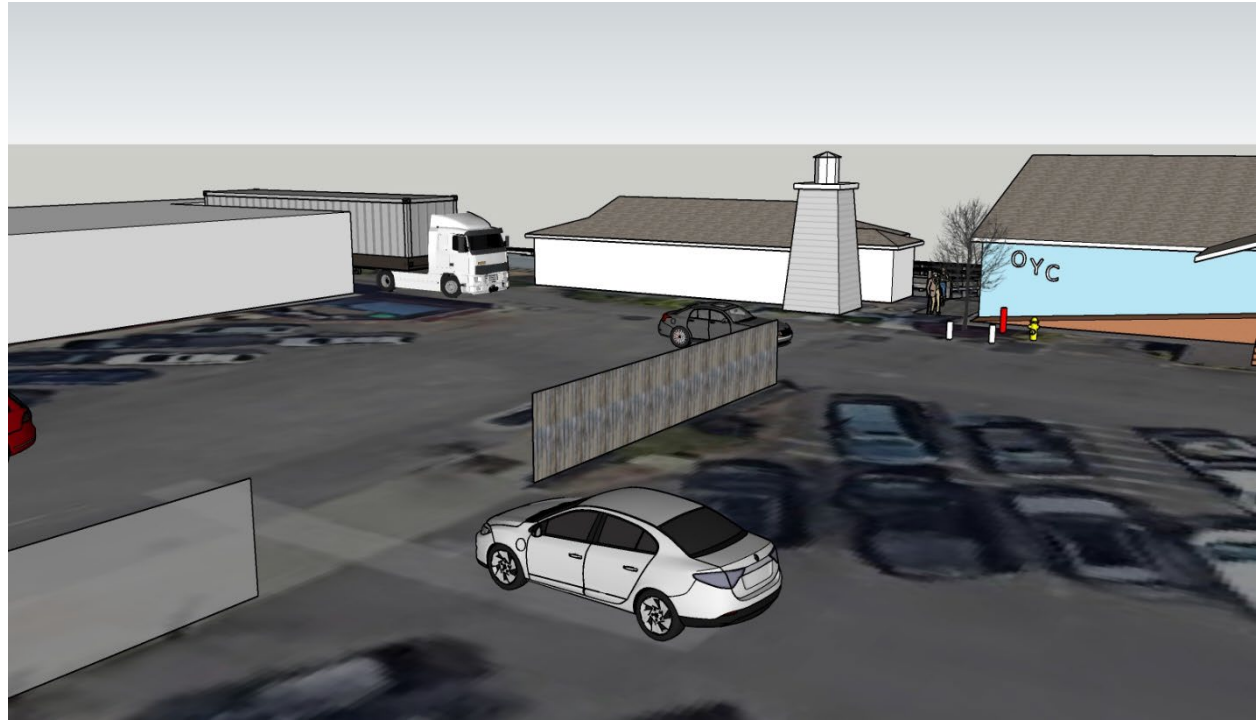
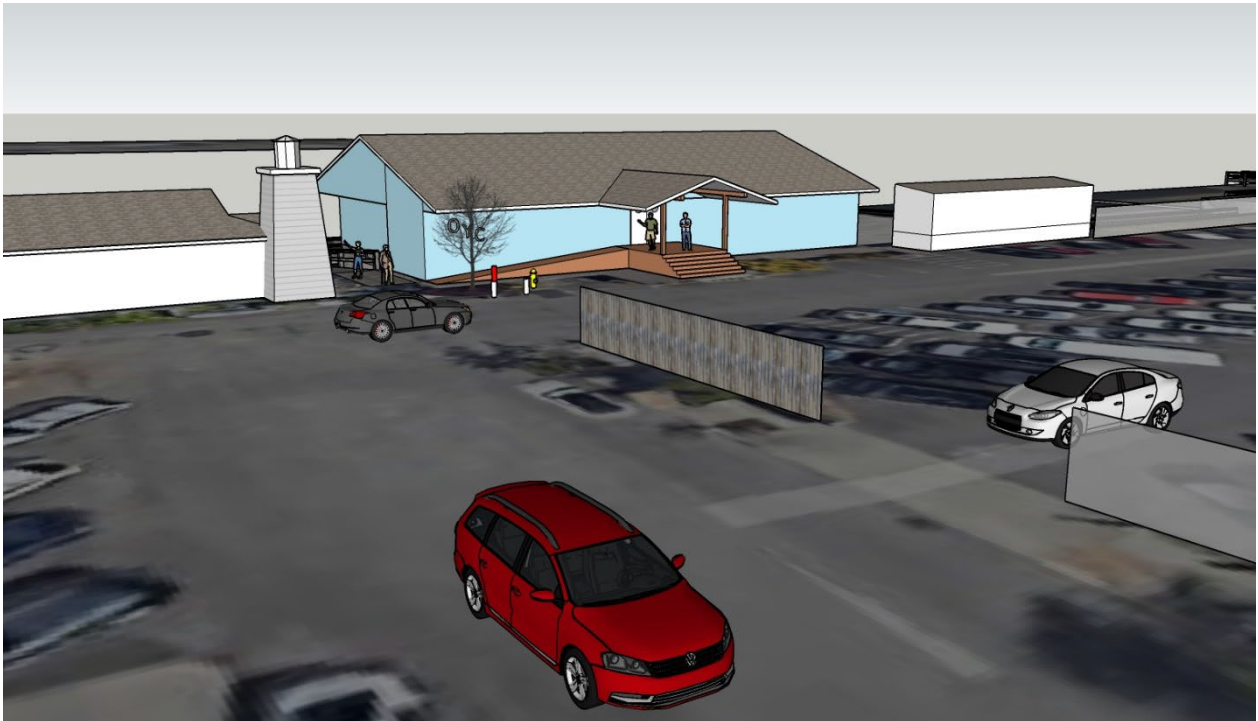
No Parking Lot Security Fence

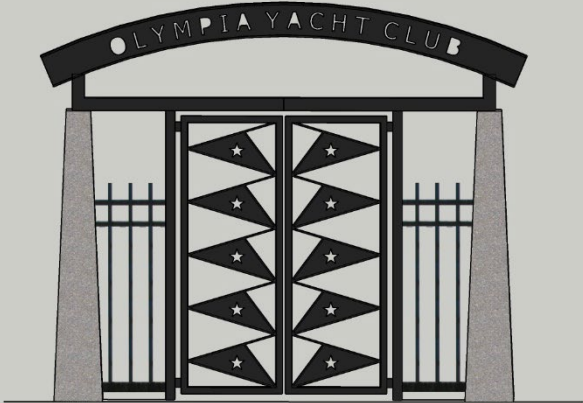
Possible Ornamental Entrance Gate Design for Options 2 & 3

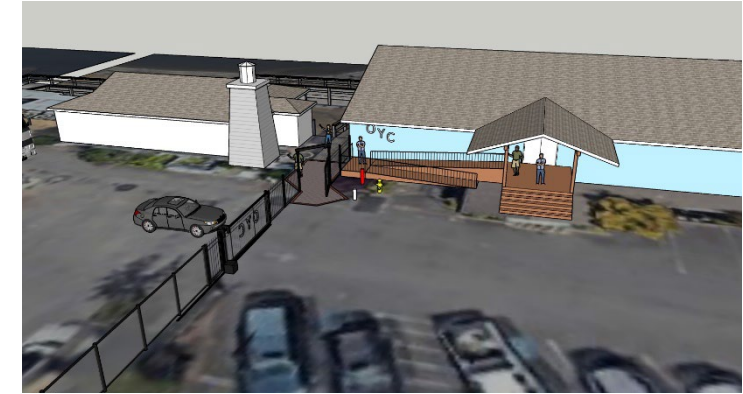
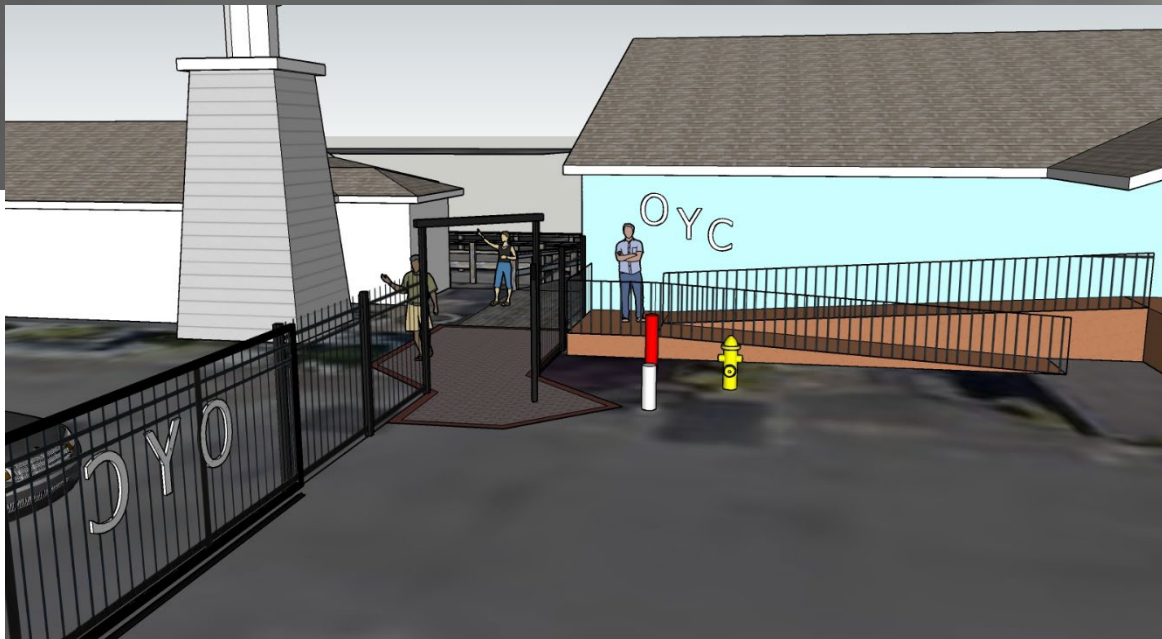
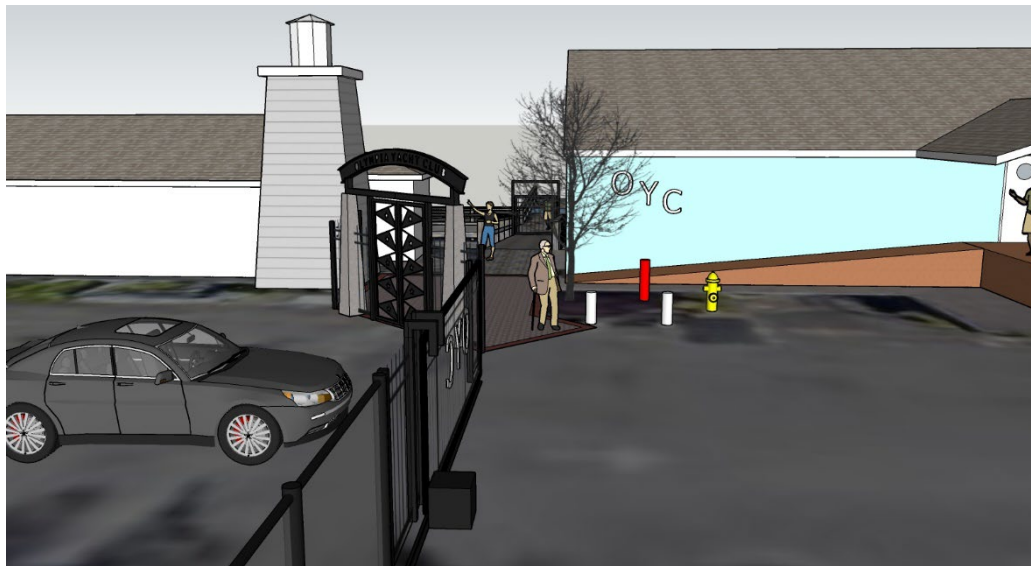
Option 1

- 1) Rebuild the ADA ramp to the clubhouse to turn back on itself so it ends in the secure parking lot.
- 2) One Security gate out of parking lot and one security gate entering docks.
- 3) Walkway open between clubhouse and caretaker house.

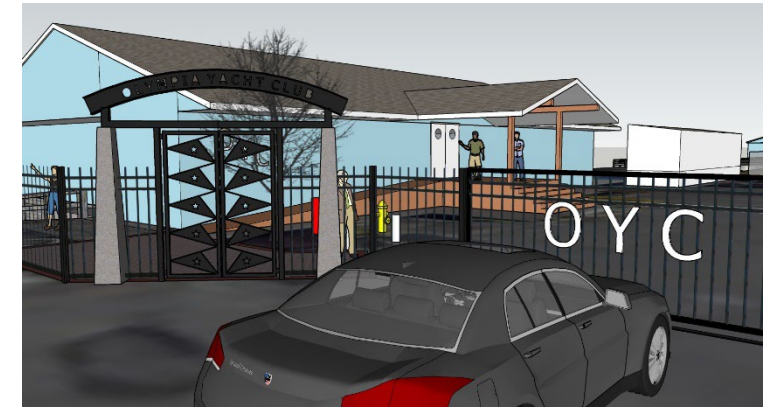
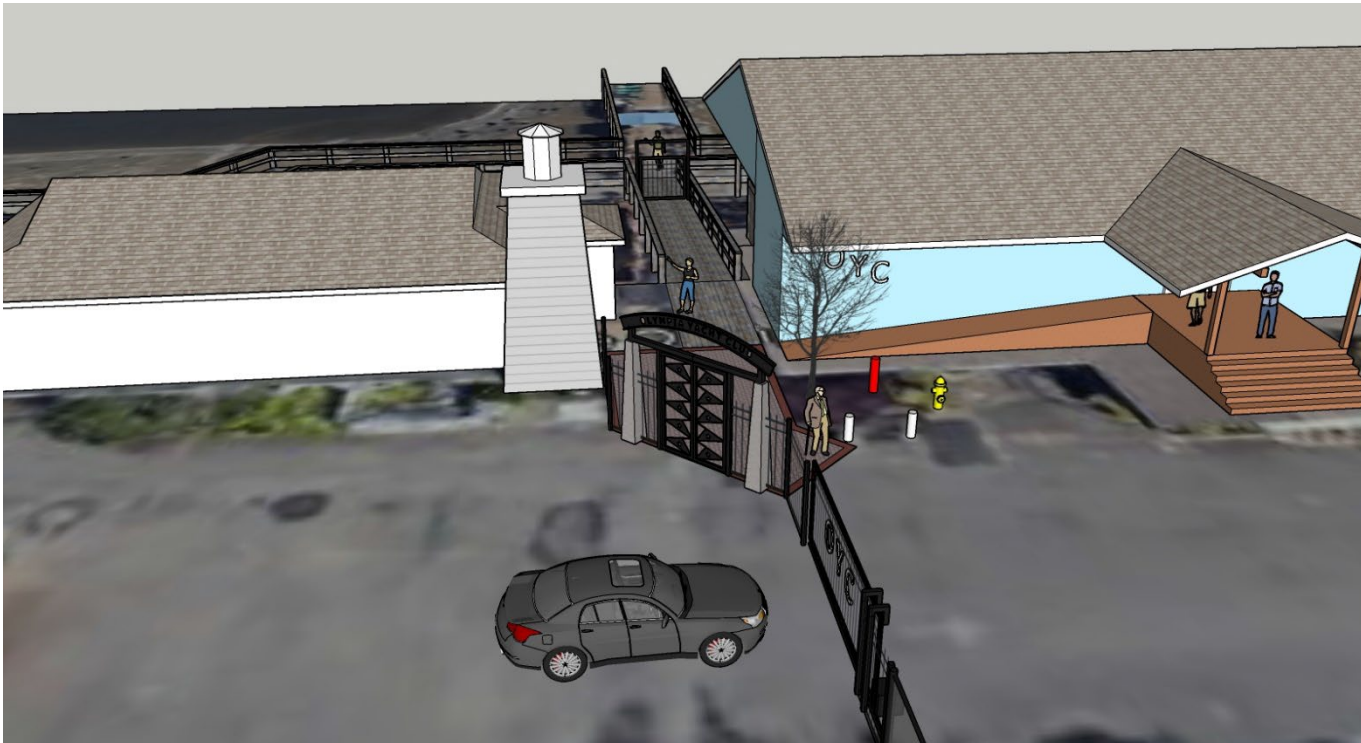
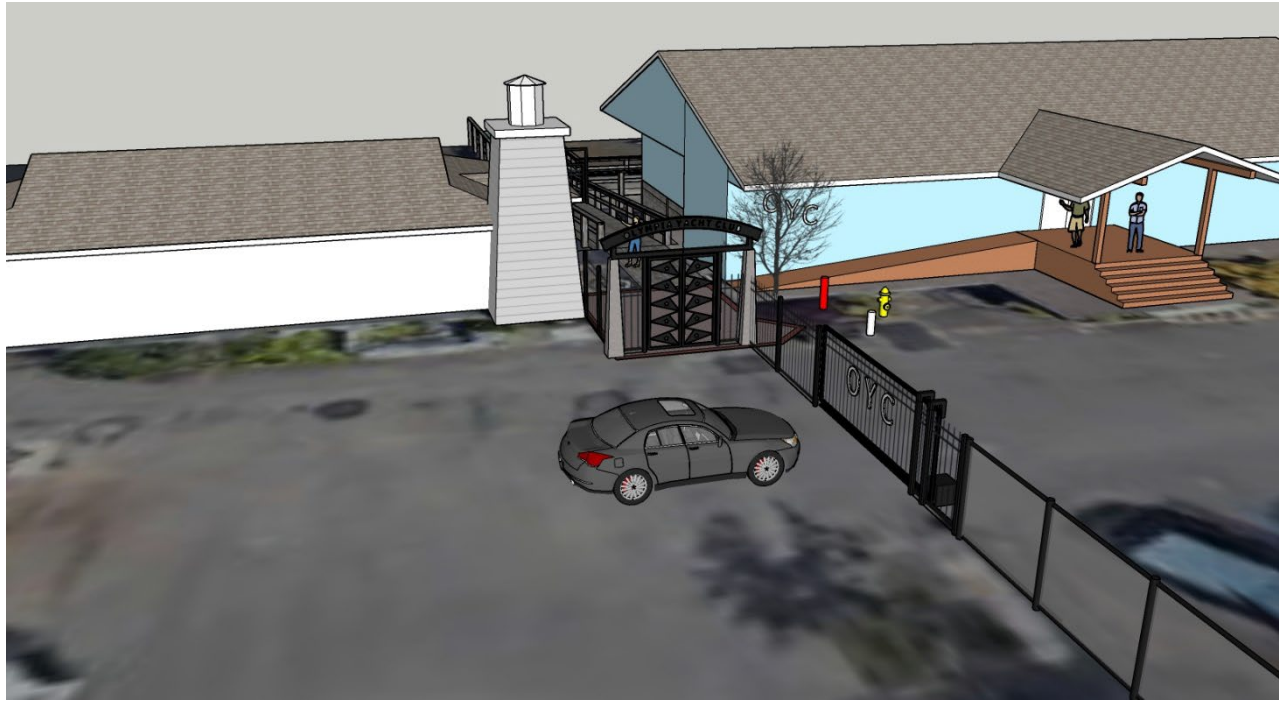
Option 2

- 1) Existing ADA ramp remains as is.
- 2) Security gate at north end of walk between clubhouse & caretaker's cottage and security gate entering docks.
- 3) Walkway closed between clubhouse and caretaker's house.

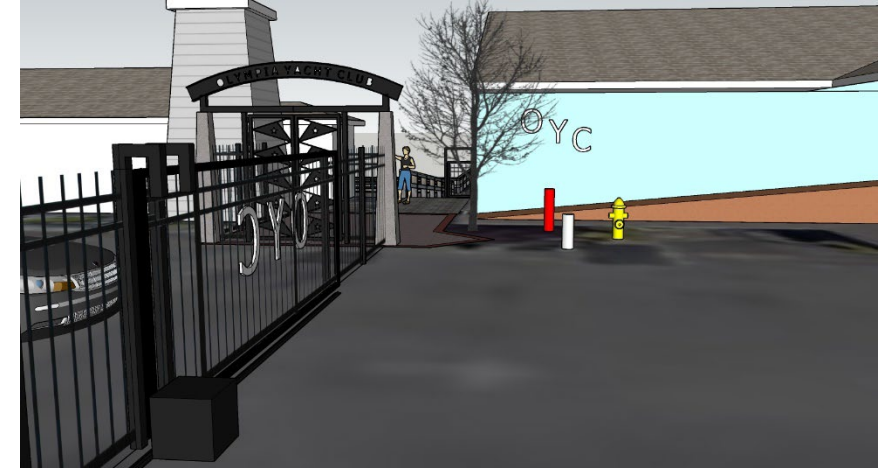
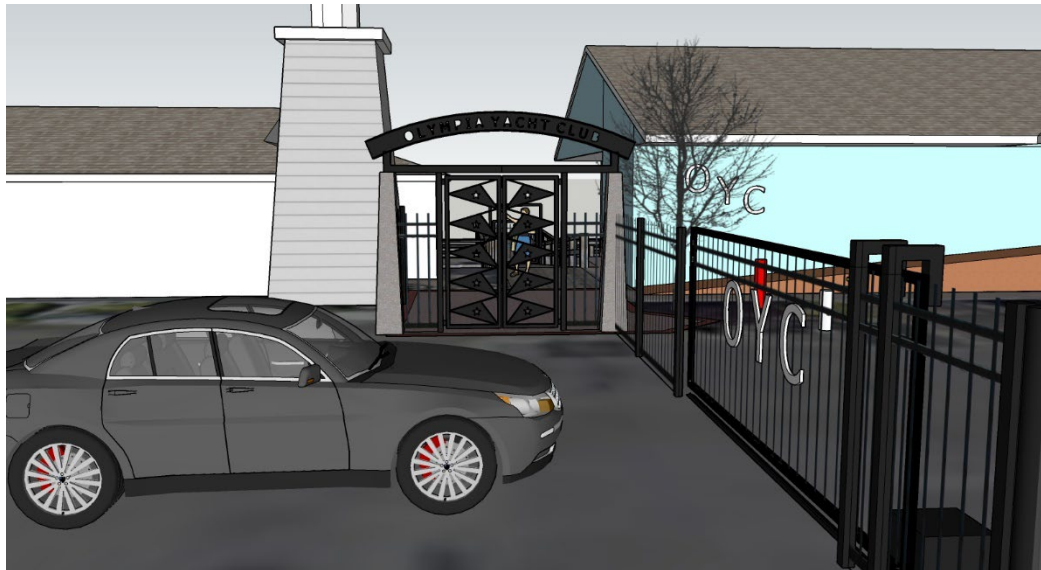
Option 3

- 1) Similar to Option 2 but gate is aligned with walk between caretaker's cottage & clubhouse.
- 2) Existing ADA ramp remains as is.
- 3) Security gate at north end of walk between clubhouse & caretaker's cottage & security gate entering docks.
